# UNDERWATER BRIDGE INSPECTION REPORT

STRUCTURE NO. 57502  
CSAH NO. 24  
OVER THE  
RED LAKE RIVER  
DISTRICT 2 - PENNINGTON COUNTY

PREPARED FOR THE  
MINNESOTA DEPARTMENT OF TRANSPORTATION  
BY  
COLLINS ENGINEERS, INC.  
JOB NO. 3512 (CEI 163)

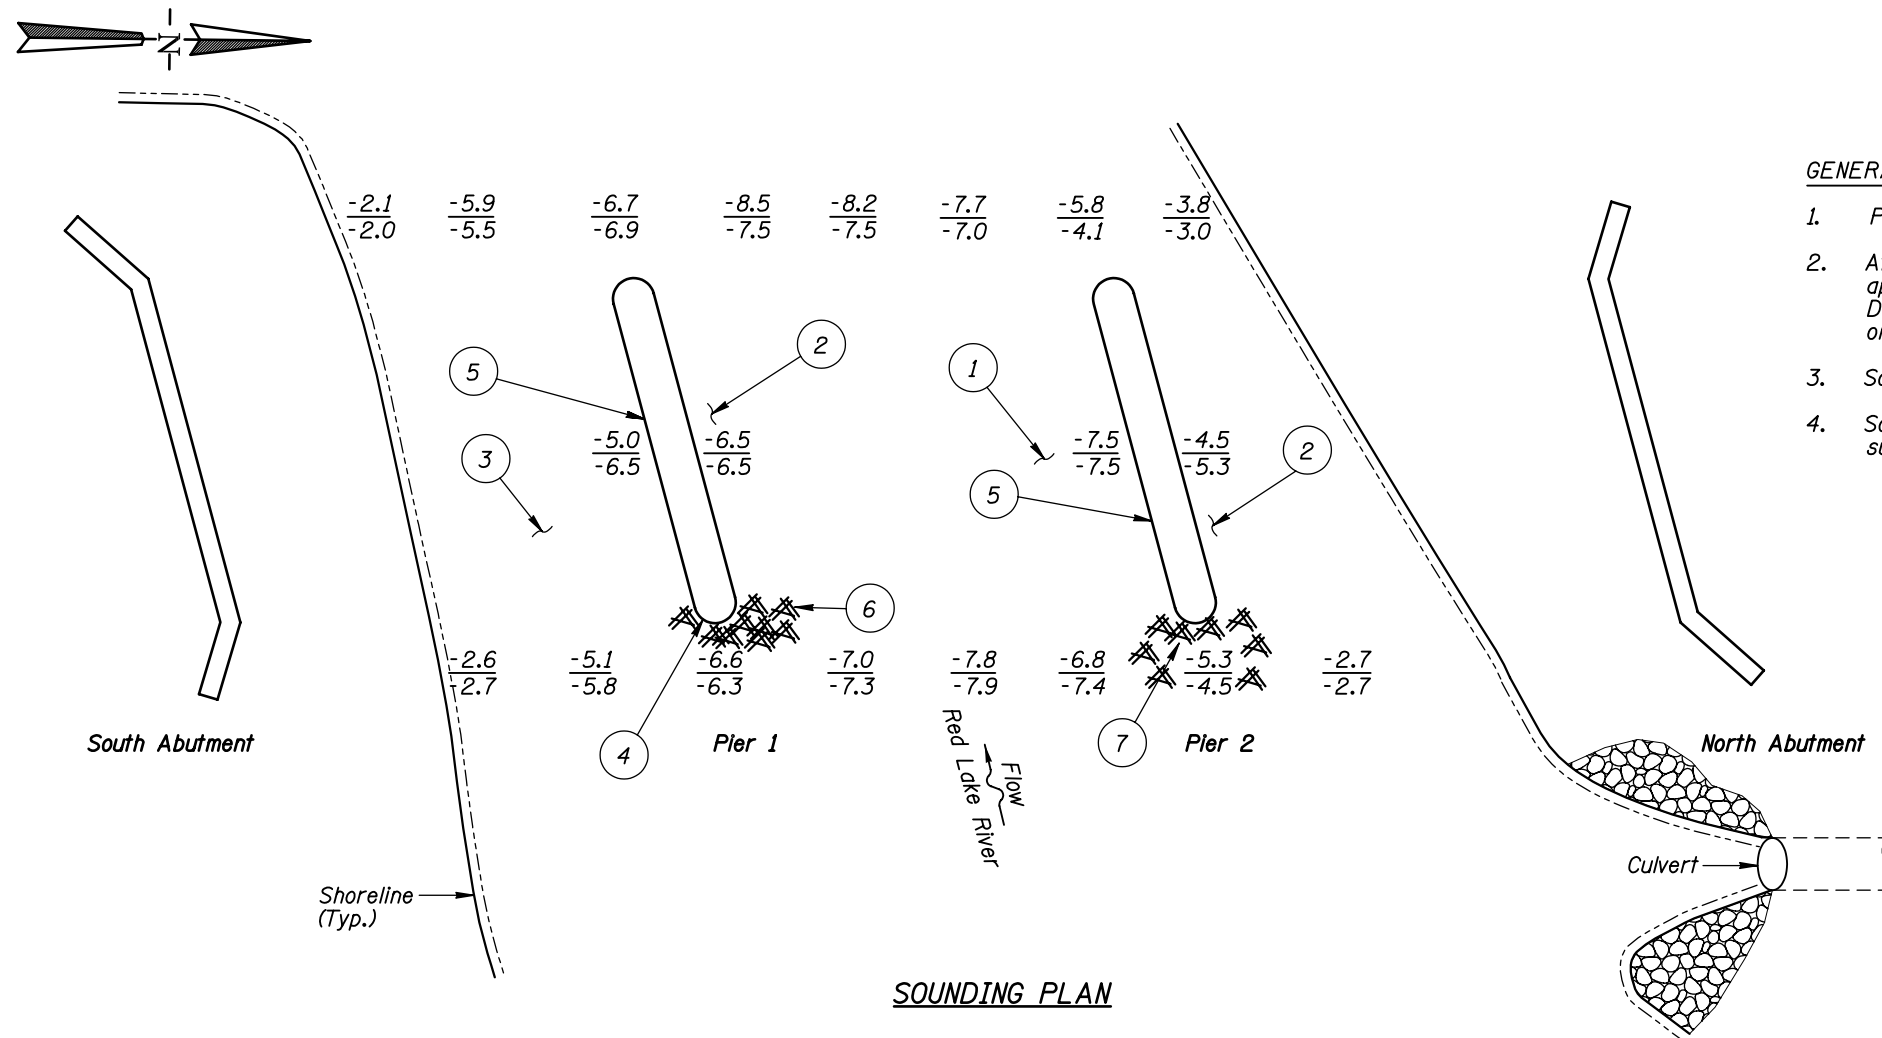
**INSPECTION AND SOUNDING PLAN**

- 1 The channel bottom material around Pier 2 consisted of gravel and 3 to 6 inch cobbles with 4 inches of maximum probe rod penetration.
- 2 The channel bottom material around Pier 1 consisted of fine sand with 12 inches of maximum probe rod penetration.

- 3 The channel bottom material between the South Abutment and Pier 1 consisted of fine sand and scattered riprap.
- 4 Area of poorly consolidated concrete at the upstream nose of Pier 1 near the waterline, measuring 2 feet wide by 1 foot high with 1/4 inch of penetration.

- 5 The concrete was generally in good and sound condition with random popouts observed on the faces of both piers.
- 6 Light to moderate timber and organic debris with branches measuring up to 6 inches in diameter were observed from 3 feet below the waterline to the mudline and extended 4 feet out from the upstream nose of Pier 1.

- 7 Light to moderate timber and organic debris was observed from the waterline to the mudline and extended 5 feet out from the upstream nose of Pier 2.

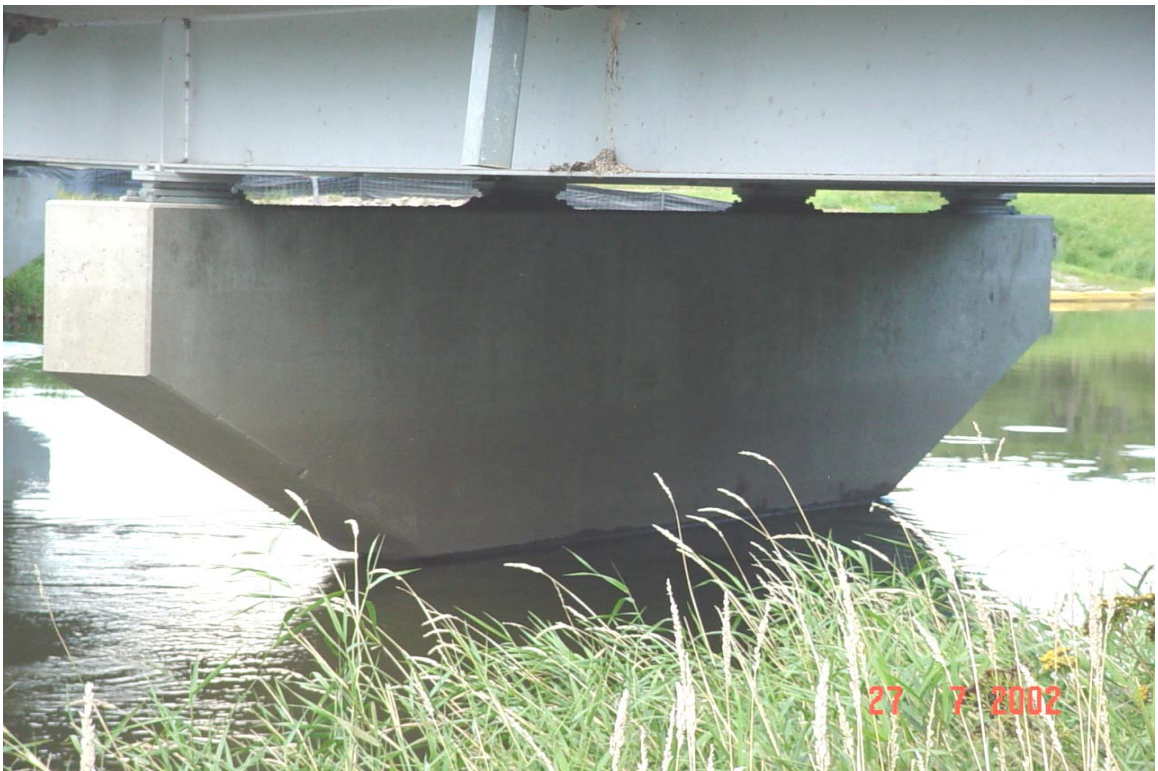
Photograph 2. View of Pier 1, Looking Northeast.

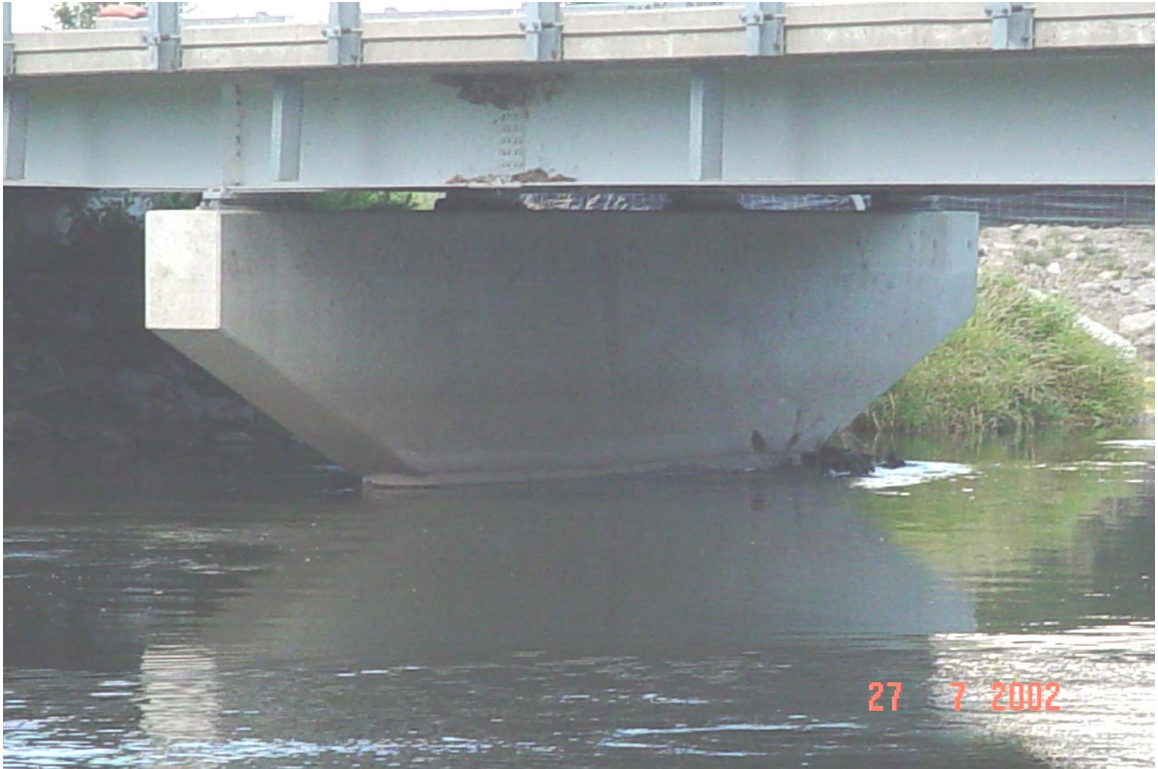
Photograph 3. View of Pier 2, Looking Northeast.

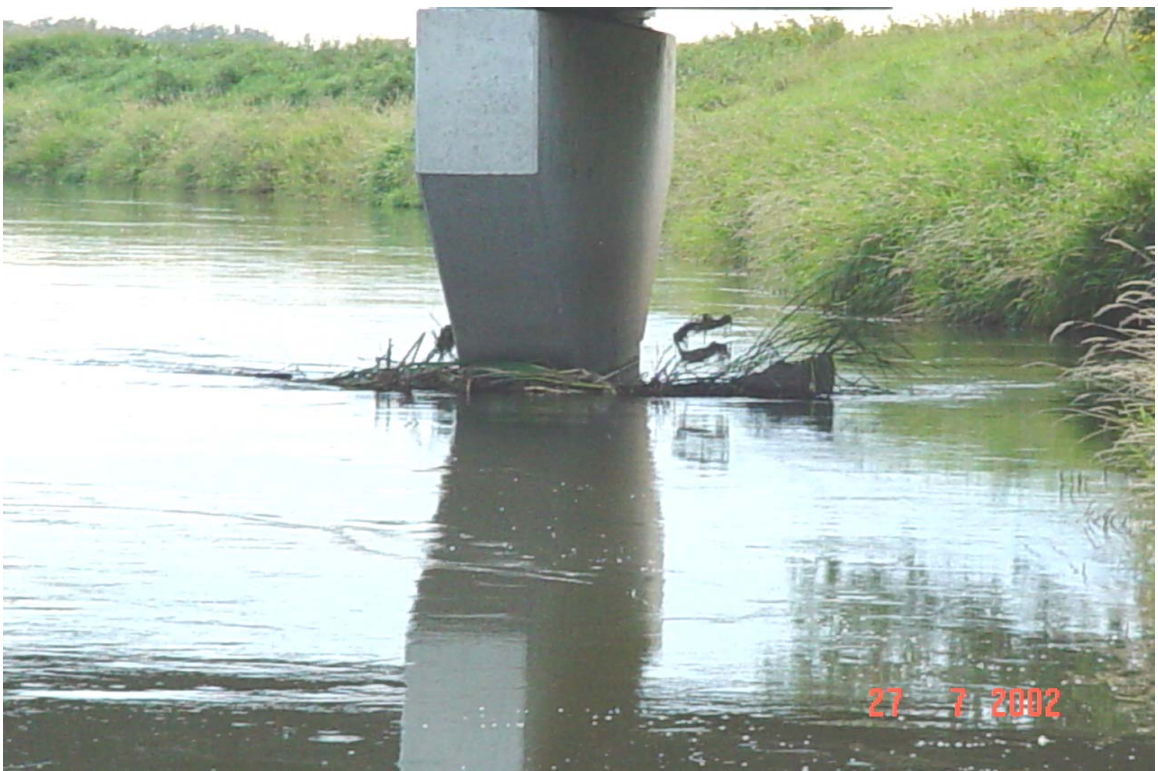
Photograph 4. View of Debris at Pier 2, Looking West.

Monitor drift for increases in amount of accumulation during future inspections.
